# Manhole Inspection Summary

Manhole # S63U\_\_001MH

**Location** Address: **5300 Holabird Ave.**

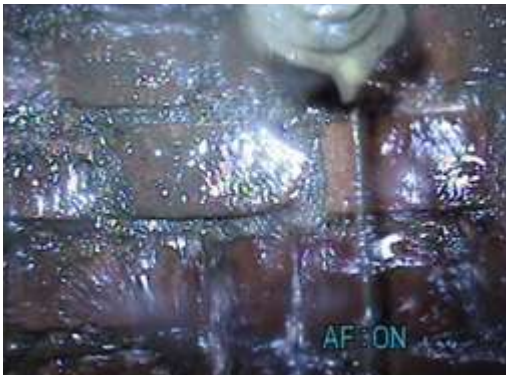
Defect 1

Comments **HEAVY DEBRIS IN OUTGOING PIPE. GUSHING DEFECTS IN BARREL.**

Infiltration: ☐ None ☒ **Joint** ☒ **Cracks** ☒ **Mortar** ☐ Roots ☒ **Wall**

Gusher through wall of barrel

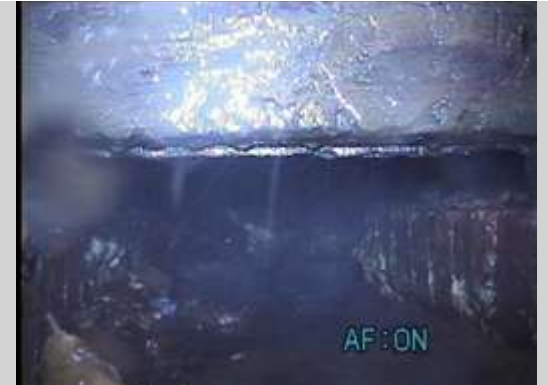
12 O'Clock Outflow

24.0 in. (w) x 15 in. (h) U-shape with flat top Gravity Sewer  
Pipe Out @ 12 O'Clock

Pipe Height: **15.6** (in.) Rod and Bar (Angled)  
Pipe Material: **Clay** ☐ Pipe Lined  
Invert Depth: **11.63** (ft.) Flow Characteristics: **Fast**  
Deposits: ☐ None ☐ Mud ☐ Sludge ☒ **Debris** ☐ Grease  
Silt Depth: **4** (in.) Deposits Extent: **Medium**  
Infiltration: **None** Pipe Seal Cond: **Sound**

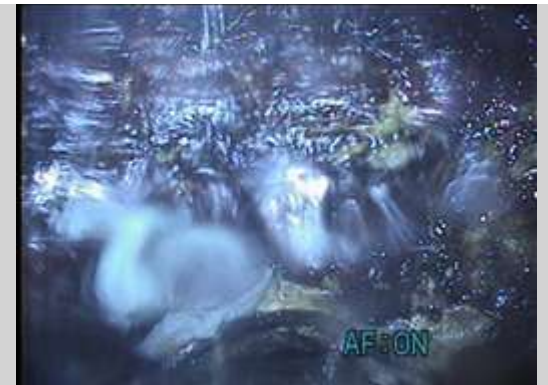
6 O'Clock Inflow

Too much infiltration to get clear picture.

Pipe Height: **8.4** (in.) Rod and Bar (Angled)  
Pipe Material: **Clay** ☐ Pipe Lined  
Invert Depth: **11.58** (ft.) Flow Characteristics: **Fast**  
Deposits: ☐ None ☐ Mud ☐ Sludge ☒ **Debris** ☐ Grease  
Silt Depth: **2** (in.) Deposits Extent: **Medium**  
Infiltration: **None** Pipe Seal Cond: **Sound**

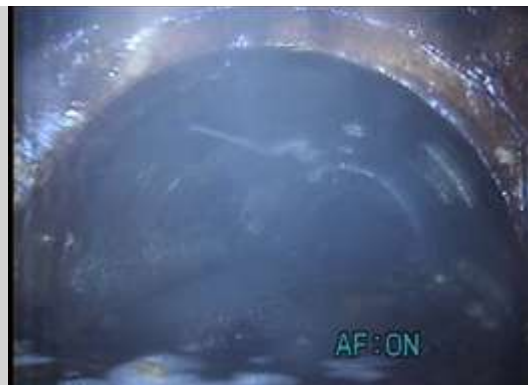
8 O'Clock Inflow

15 in. Circular Gravity Sewer  
Pipe In @ 8 O'Clock
